Manhole Inspection Summary

Manhole # S03QQ1026MH

Location Address: **5500 NARCISSUS AVE** Cross Street: **W ROGERS AVE**

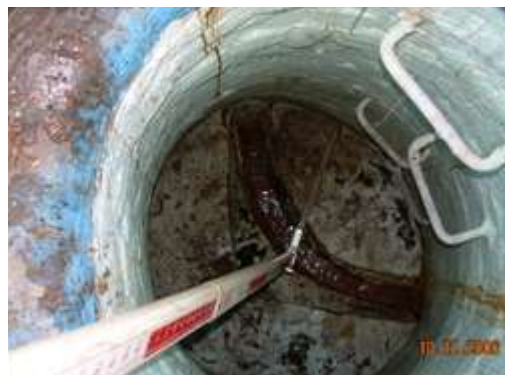
Top View

Frame offset. Bench debris.

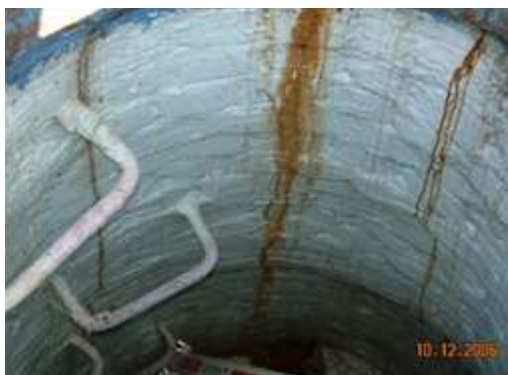
Defect

Frame Offset: **4** (in.) Condition: ☐ Sound ☐ Cracked ☒ **Leaks**

Chimney / Frame Adjustment ☒ Exists Material: **Unknown** ☐ Parged Height: **10** (in.)
Condition: ☒ Sound ☐ Cracked ☐ Root Intrusion ☐ Loose Brick ☐ Deteriorated
Infiltration: ☐ None ☒ **Joint** ☐ Cracks ☐ Mortar ☐ Roots ☐ Wall

Frame leaks. Adjustment infiltration.

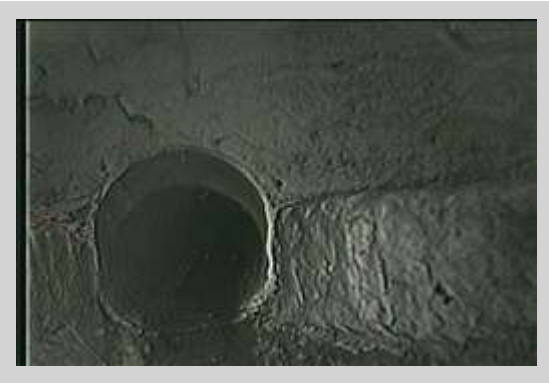
8 in. Circular Gravity Sewer Pipe Out @ 12 O'Clock

Pipe Material: **Unknown** ☒ Pipe Lined

Invert Depth: **8.24** (ft.) Flow Characteristics: **Slow**

Infiltration: **None** Pipe Seal Cond: **Unknown**

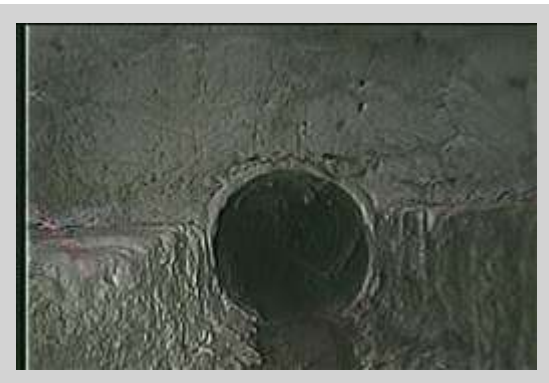
8 in. Circular Gravity Sewer Pipe In @ 3 O'Clock

Infiltration: **Evidence** Pipe Seal Cond: **Unknown**
